CERCLA Site Inspection

Tapemation Machine, Inc.  
21 El Pueblo Road  
Scotts Valley, CA 95066

Inspection ID Number: C(85)C320

Date of Inspection: 7/11/85

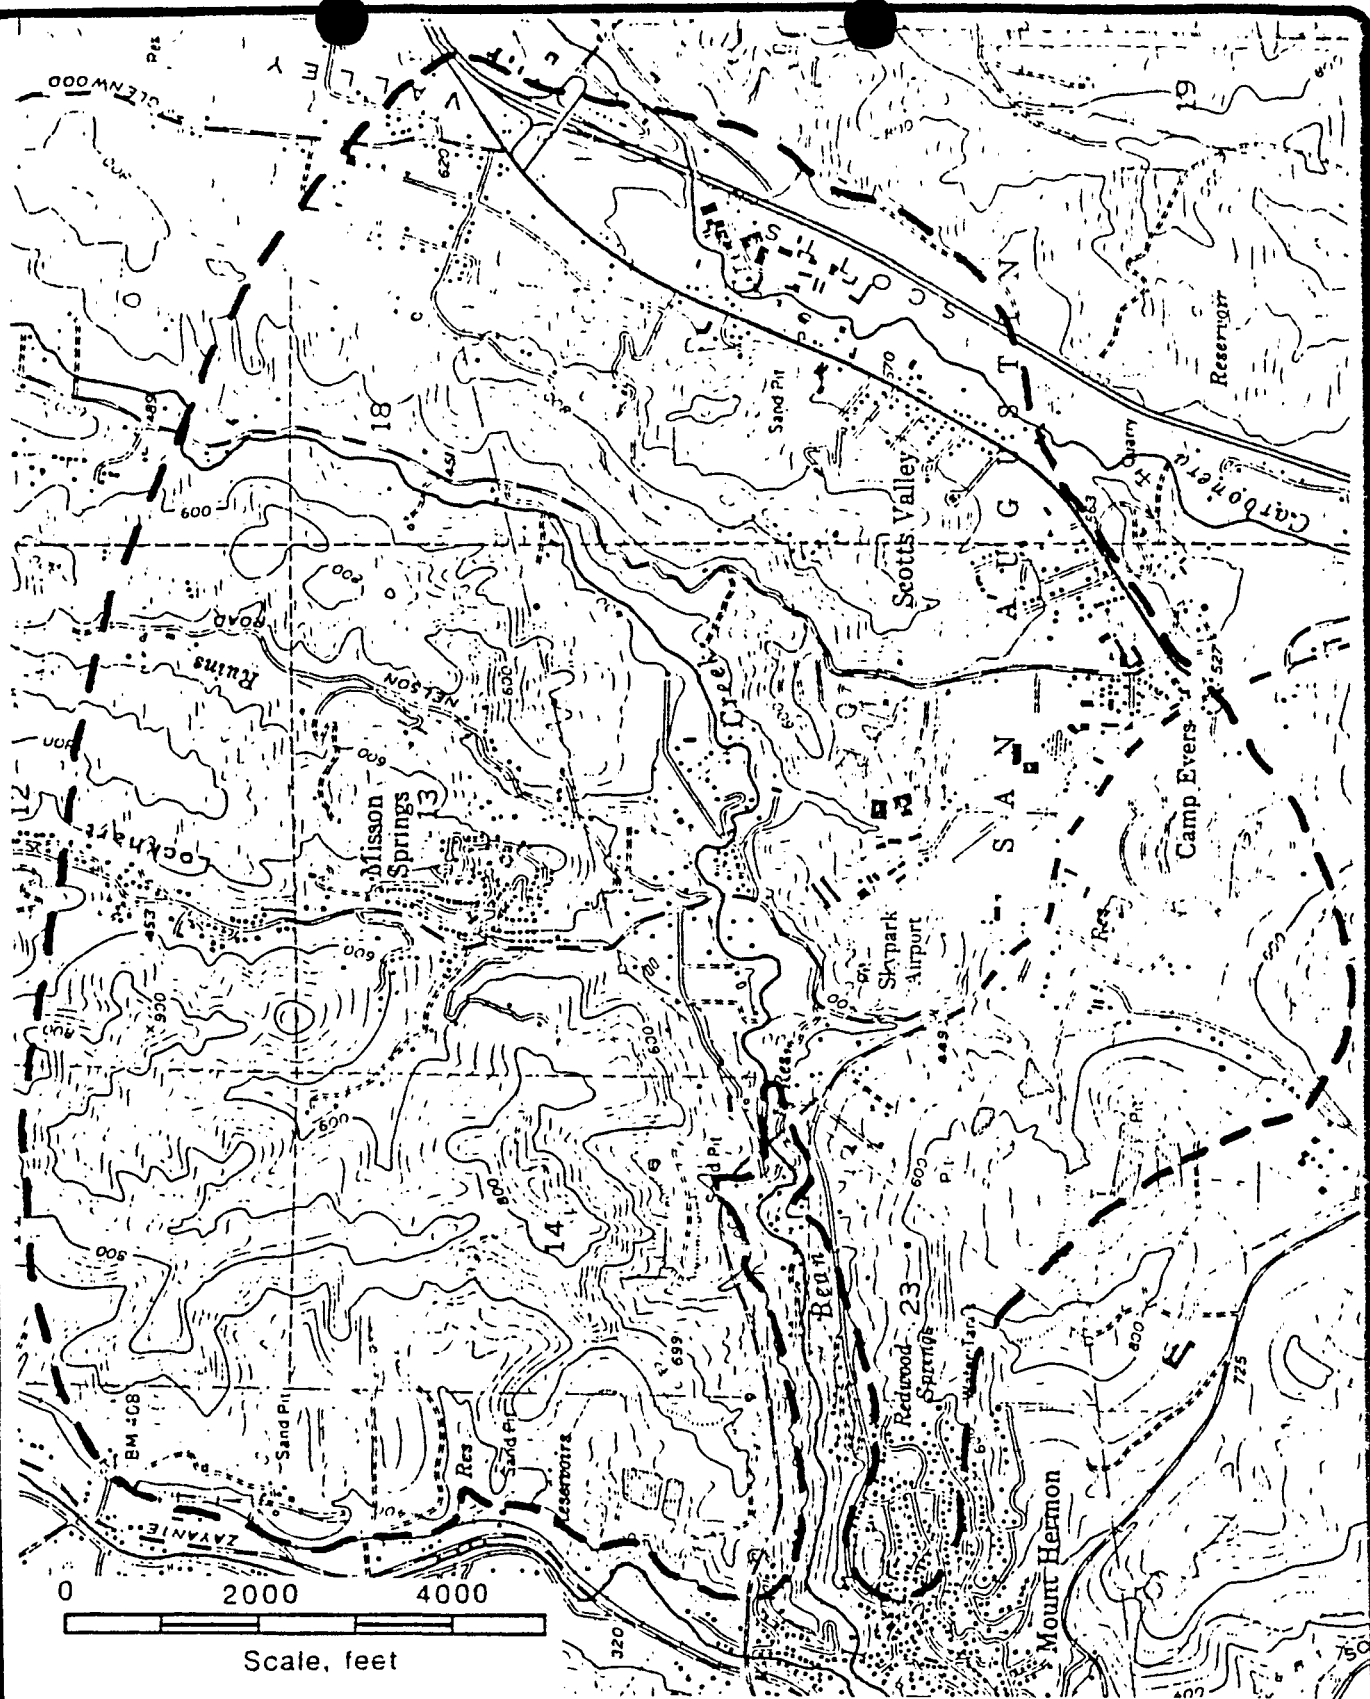
**FIGURE 3.1**

**Approximate Boundary of the Saturated Santa Margarita Aquifer**

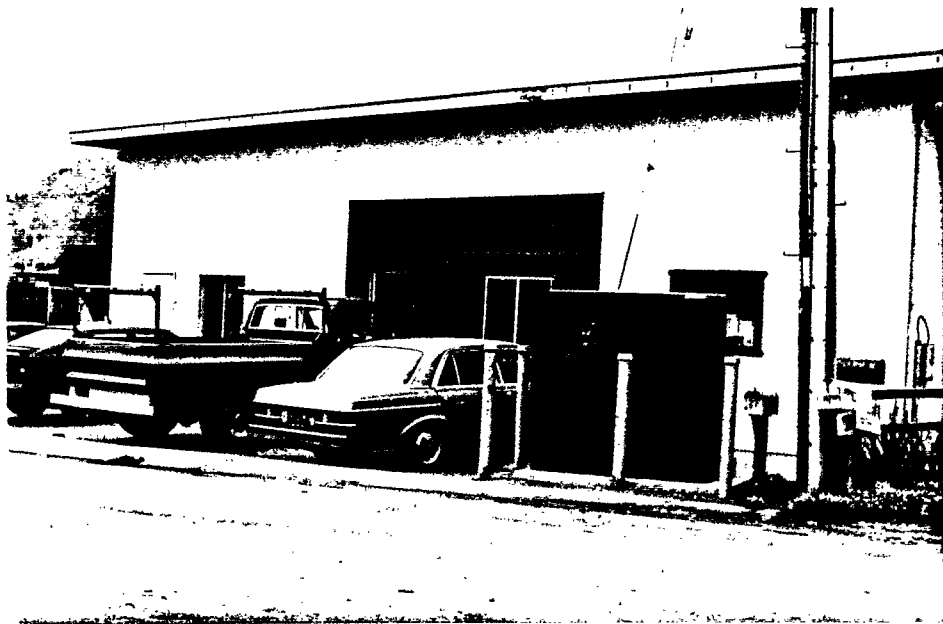
1. Entrance to facility, 7/11/85

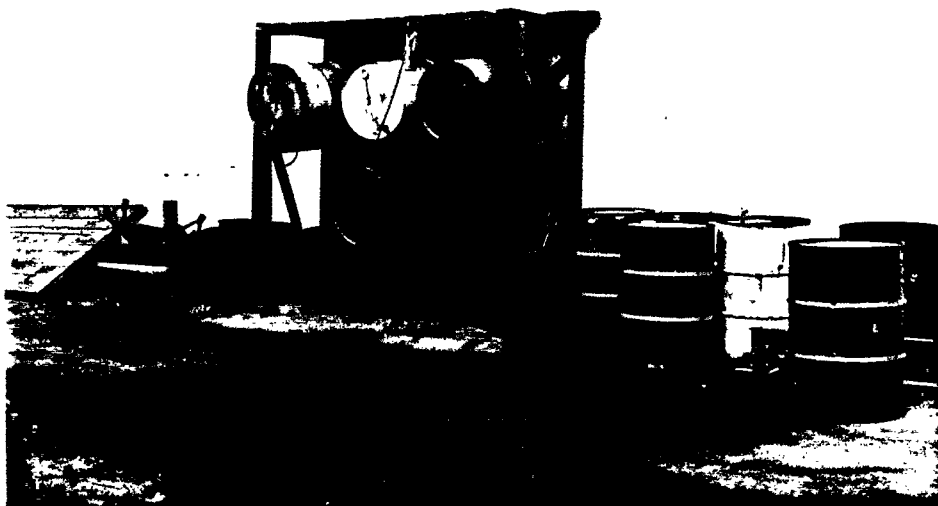
Gasoline, cutting oil, lubricating oil, water soluble liquid cleaner, Turbine oil, and Way oil are stored in 55 gallon drums in a rack outside the facility. Acetone, kerosene, paint thinners, motor oil, and any other materials are stored at various locations inside the facility.

Machines are drained of used oil which is put in small containers and then pumped to a 55 gallon drum in the outside storage area. Waste oil is subsequently picked up by the Renn Oil Company (Santa Cruz, California) and recycled. Cutting oils are recycled on-site. Solvents are used in wiping operations and the contaminated rags are picked up and cleaned by Mission Linen Supply. There are minimal amounts of wastes associated with the use of lacquers, thinners, and paint. Excess metal shavings called "chips" are stored outside in 4 foot by 4 foot steel bins and hauled off-site by Diamond Metals.

2. Outside storage area, 7/11/85
